Manhole Inspection Summary

Manhole # S23A__030MH

Location Address: **1300 CALHOUN-ALLEY-CAREY**

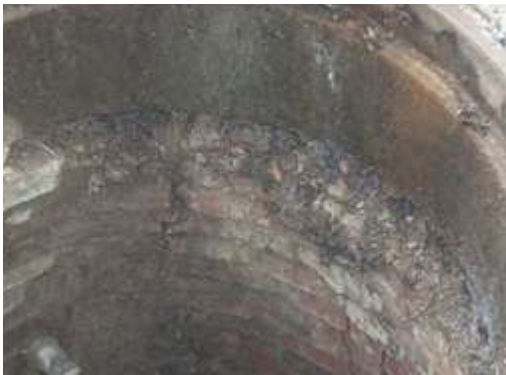
Defect 3

Condition: ☐ Sound ☐ Cracked ☐ Root Intrusion ☐ Loose Brick ☒ **Deteriorated**

DETERIORATION OF CHIMNEY

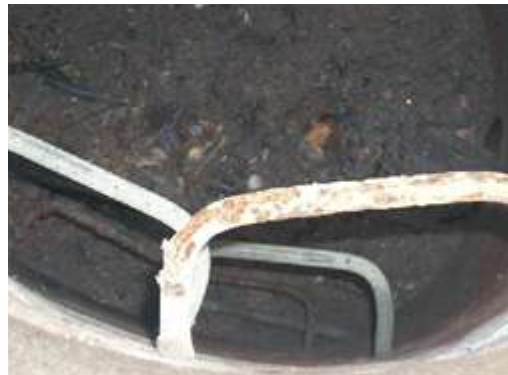
Defect 2

Count: **3** Missing: **0** ☒ **Corroded**

CORRODED STEPS

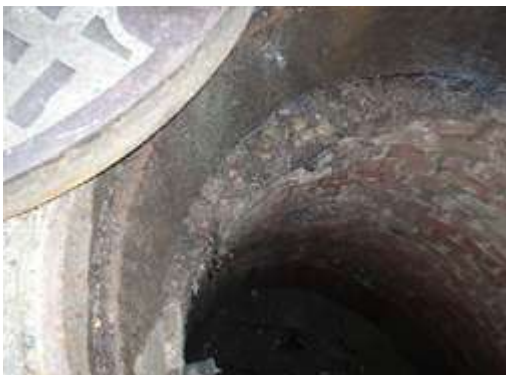
Defect 1

Offset: **2** (in.)

FRAME OFFSET

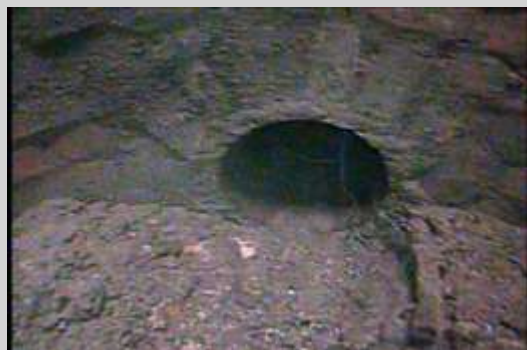
12 O'Clock Outflow

8 in. Circular Gravity Sewer
Pipe Out @ 12 O'Clock

Infiltration: **None** Pipe Seal Cond: **Sound**
